Contract #: 04-0120F4Cty: SF/ALA Rte: 80 PM: 13.2/13.9File #: 69.28**WELDING INSPECTION REPORT****Resident Engineer:** Pursell, Gary**Address:** 333 Burma Road**City:** Oakland, CA 94607**Report No:** WIR-004645**Date Inspected:** 16-Nov-2008**Project Name:** SAS Superstructure**OSM Arrival Time:** 700**Prime Contractor:** American Bridge/Fluor Enterprises, a JV**OSM Departure Time:** 1730**Contractor:** Zhenhua Port Machinery Company, Ltd (ZPMC), Changxing Island **Location:** Shanghai, China**CWI Name:** Wen Peng, Um Bin**CWI Present:** Yes No**Inspected CWI report:** Yes No N/A**Rod Oven in Use:** Yes No N/A**Electrode to specification:** Yes No N/A**Weld Procedures Followed:** Yes No N/A**Qualified Welders:** Yes No N/A**Verified Joint Fit-up:** Yes No N/A**Approved Drawings:** Yes No N/A**Approved WPS:** Yes No N/A**Delayed / Cancelled:** Yes No N/A**Bridge No:** 34-0006**Component:** OBG**Summary of Items Observed:**

WELDING INSPECTION REPORT

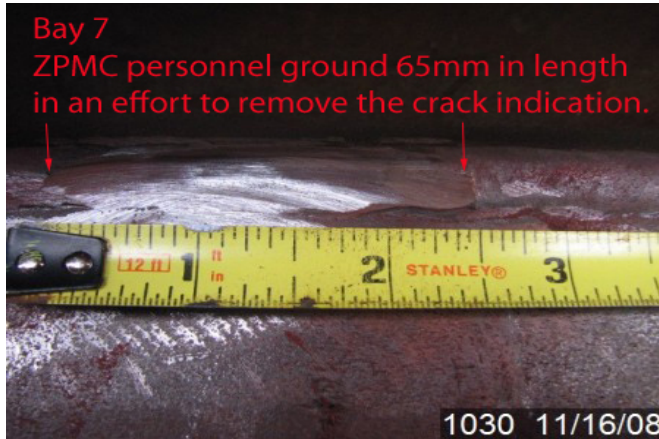
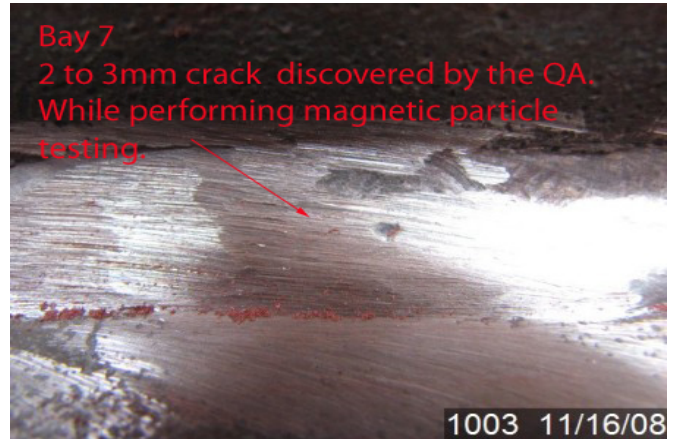
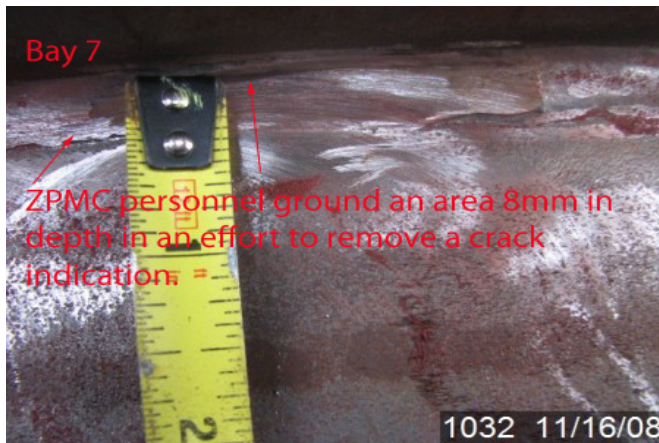
The Quality Assurance Inspector discovered a 2 to 3mm crack indication overlooked by ZPMC Quality Control Inspectors. The crack indication was discovered while the QA was performing magnetic particle verification on weld # FB011-017-003 located on the FB011-017 floor beam sub assembly. The Quality Assurance Inspector informed American Bridge/Fluor Quality Assurance Inspector Um Bin about the crack indication overlooked by ZPMC Quality Control Inspectors. Mr. Bin and ZPMC Quality Control Inspector Wen Peng agreed with the Quality Assurance Inspector that the crack indication was overlooked by ZPMC Quality Control Inspectors. The Quality Assurance Inspector observed ZPMC personnel have removed an area 8mm in depth and 65mm in length of filler metal by grinding in an effort to remove the indication discovered by the Quality Assurance Inspector is a surface indication. ZPMC Quality Control Inspector Wen Peng informed the Quality Assurance Inspector ZPMC

personnel performed magnetic particle testing on the ground area, revealing the crack indication is a sub surface indication. Mr. Peng informed the indication was not a crack indication and does not need to be a critical weld repair, than the Quality Assurance Inspector asked Mr. Peng if the indication was a not a crack than why would he agreed with Quality Assurance Inspector about the indication being a crack indication. The Quality Assurance Inspector than asked Mr. Peng why would he remove 8mm of weld metal by grinding if the indication was a crack. Mr. Peng admitted to the Quality Assurance Inspector he did not want to issue a critical weld repair because the floor beam needed to be green tagged on this date. Mr. Peng admitted to the Quality Assurance Inspector The indication was crack and he will issue a critical weld repair. See Caltrans report TL-15 for additional information.
